ROOFS east wing continued

ROOFS continued

DRAINAGE

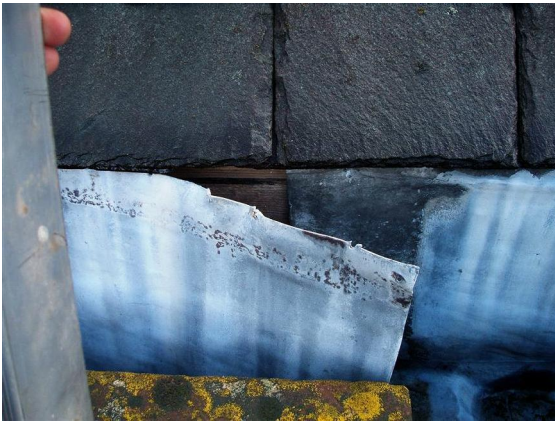
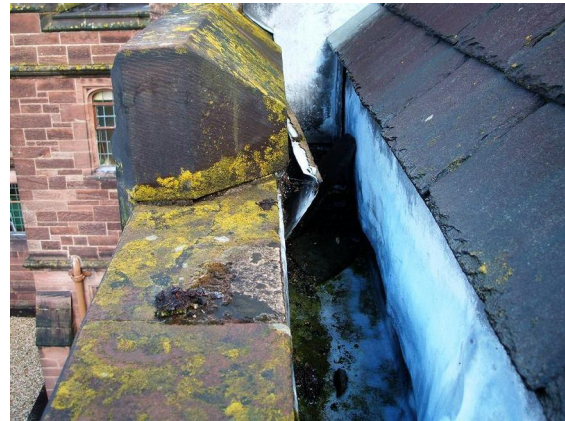
Flashing loose and falling away to south west gutter, some debris.

Refix; clear.

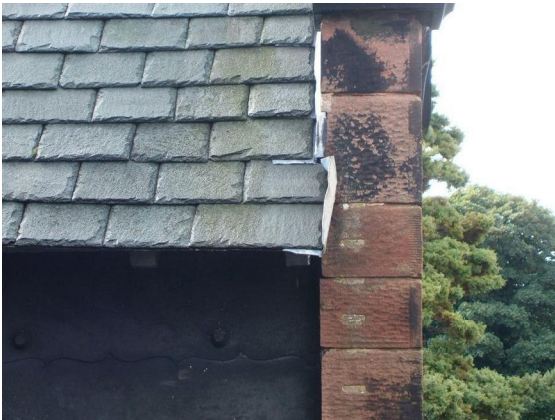
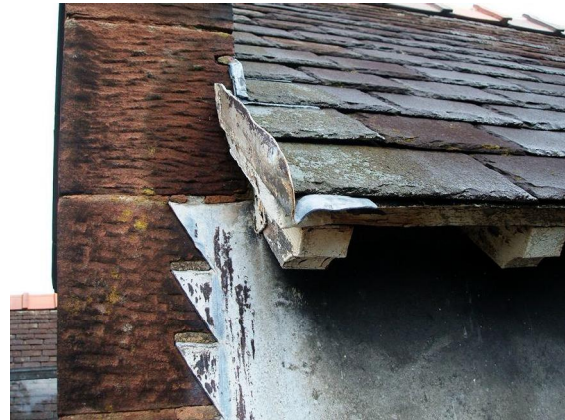
Lead dormer cheeks good, but fixings loose, copings open jointed. Eaves timbers to access dormer, paintwork poor.

Refix & repaint.

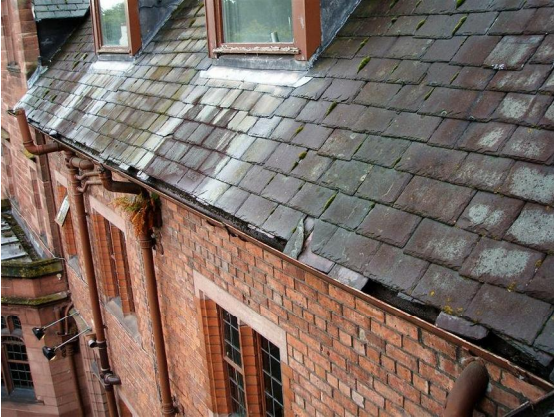
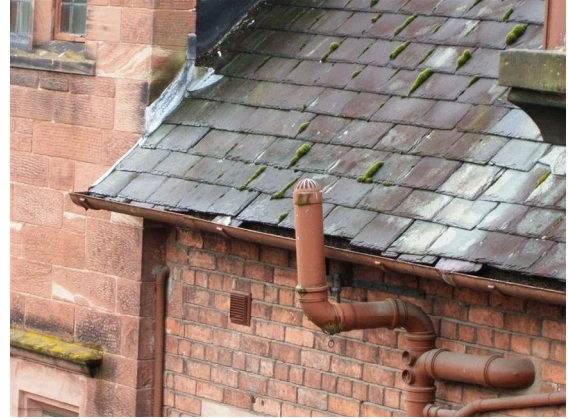
Leadwork as before, return of valleys corroded, flashings to central gable loose, firm to south. **Overhaul.**

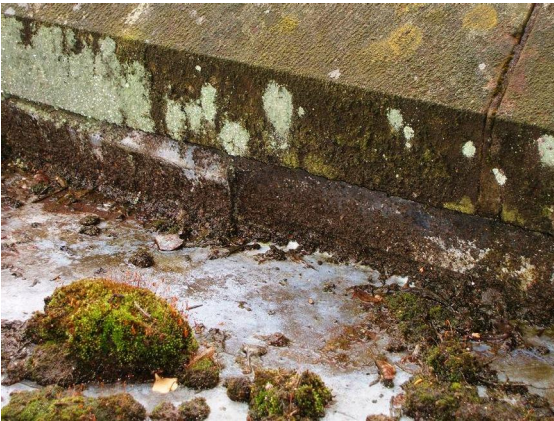
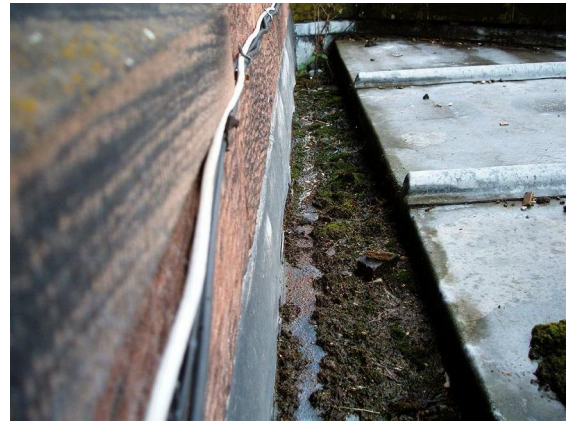
East Bay Window: To former chapel, a leaded flat, firm but slightly rucked and possibly suspect to south end; much debris.

Monitor. Locally repoint to flashings. Clear debris.

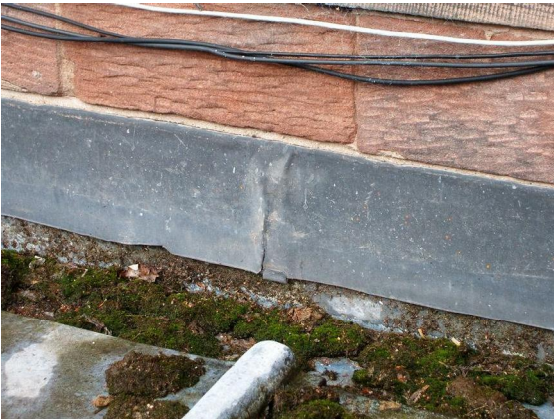
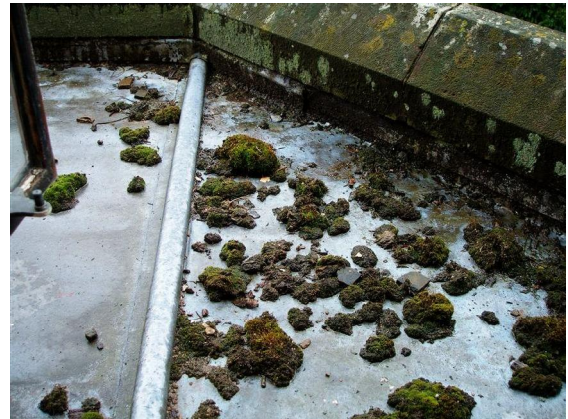
Parapet flashings loose, corroded; copings, open jointed, split up to east wall; debris.

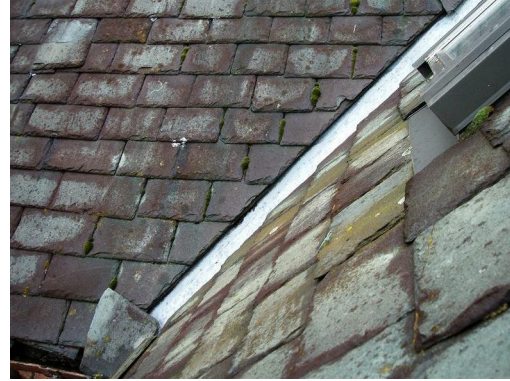
Flashings to east gable split, becoming loose high level.

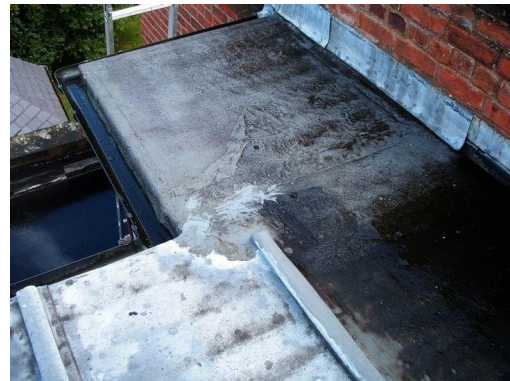
Dormer Roof: Above last, lead and mineral felt, bitumen to east, poor. Leaking. **Renew.**

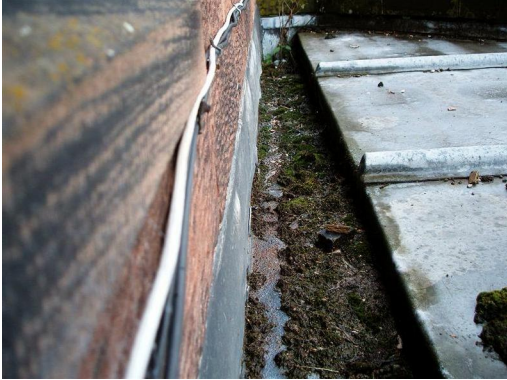
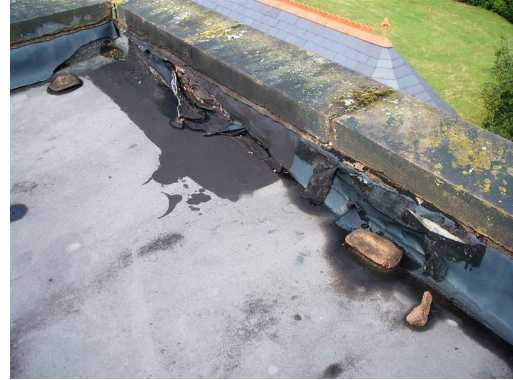
Cracking north/south to north east and north west, general failure to parapets, loose, felt covers, pointing missing; coping joints all poor.

Monitor path. Renew in due course.

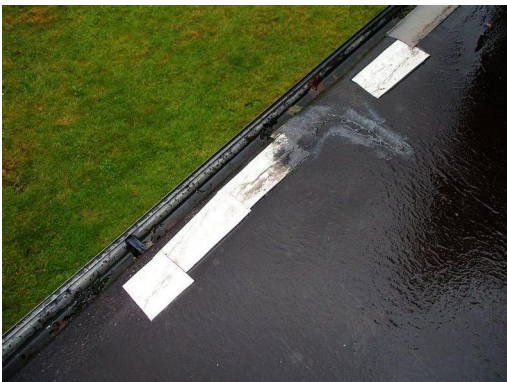
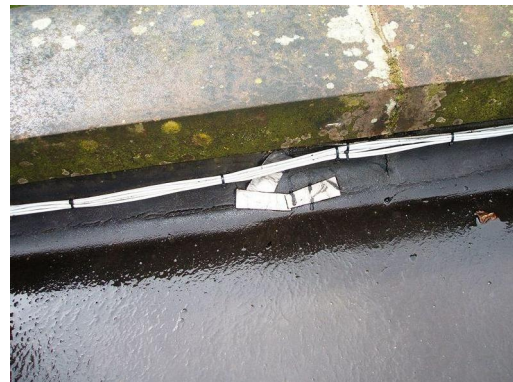
Asphalt on concrete, split and patched adjacent to eaves gutter to north and parapet to south, poor. Felt patches to south west and splits adjacent to wing to north west. Coping joints cracked to south west.

Patch, renew in due course.

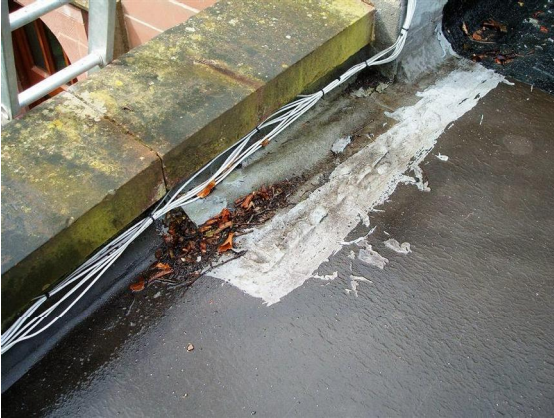
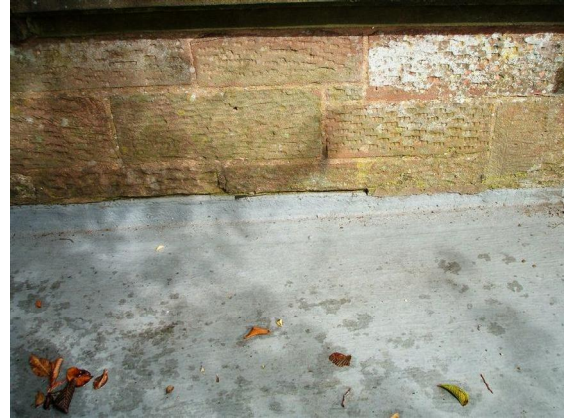
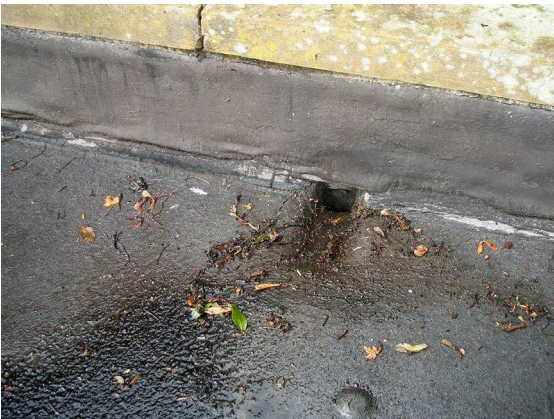
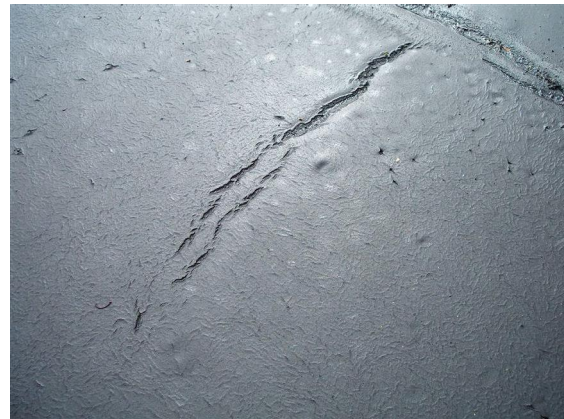
Archives: Asphalt on concrete, generally poor, extensive splitting, rucked to construction joint (?) to centre. Split and patched to parapets, flashband repairs ó large areas ponding to south of centre. Some coping joints open.

Patch, renew in due course.

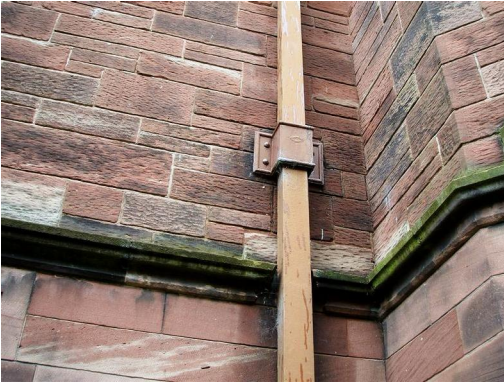
No.8: Library north west, c.i.; collar centre fixings missing, corroded rear, tight to wall, leaking. **Refix/part renew?**

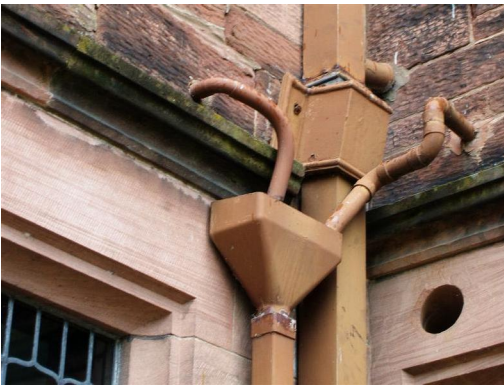
No.17: Centre block east, centre collar loose, shoe corroded, poor. P.v.c. waste pipe adjacent. **Resecure.**

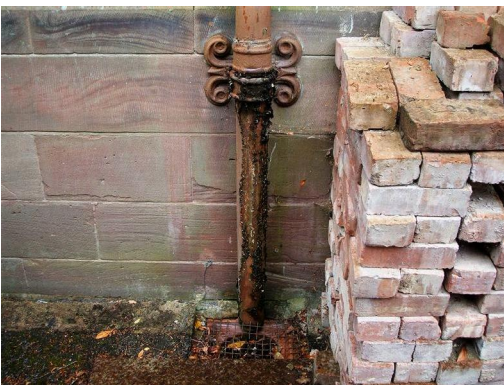
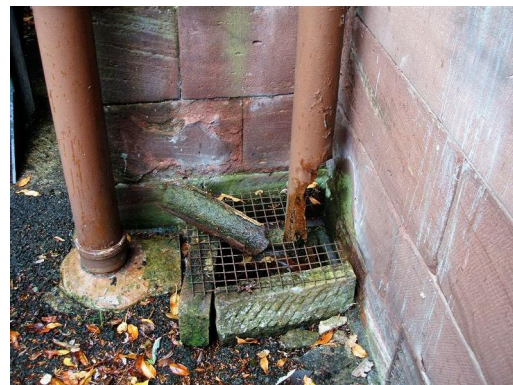
No.20: East wing south east, round section cast iron and wastes adjacent. No shoe & lower part of the pipe broken away. p.v.c. s.v.p. to south, seems to be firm. Cast iron gutter to south repaired, corroded. Misaligned connection to p.v.c. pipe to main fall pipe, p.v.c. gutter to north. Horizontal over fire escape. **Refix, clear.**

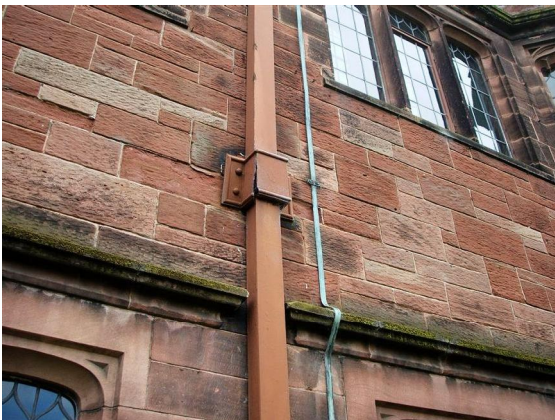
- No.30:** Central block north, lower pipe sheet metal, centre bracket broken. **Renew damage.**

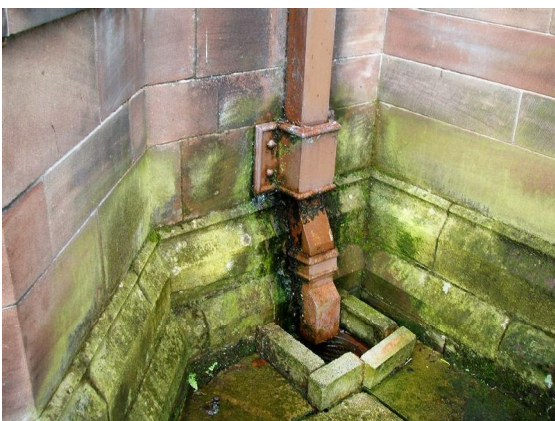
- No.31:** Central block north, ditto, sound. Recent part renewed. Poor low level, wet on wall.

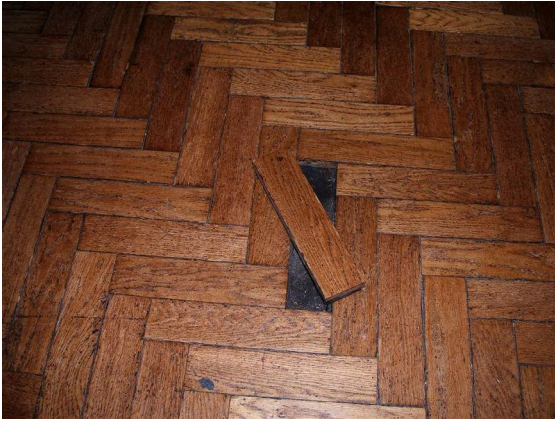
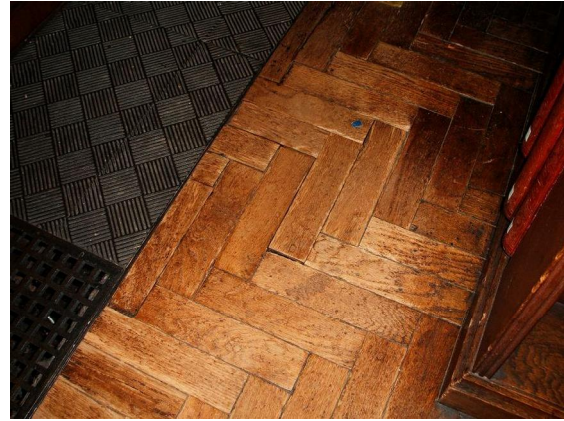
Sections uneven and loose, especially centre south & east; and locally to north & west, risen adjacent to grilles; some wide open joints many loose blocks. Areas worn.

Locally reset and generally refinish.

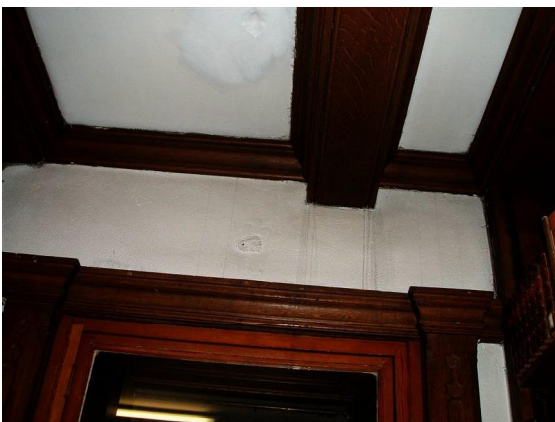
Plastered to rear of and above bookcases. Locally damaged plaster over east entrance door at high level.

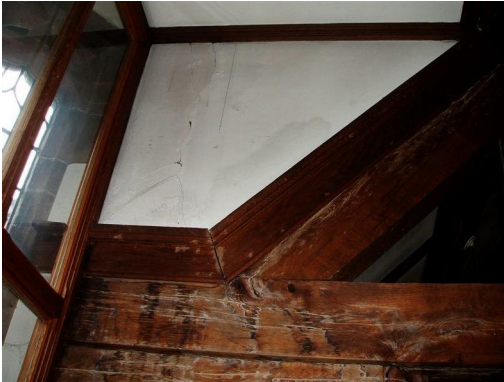
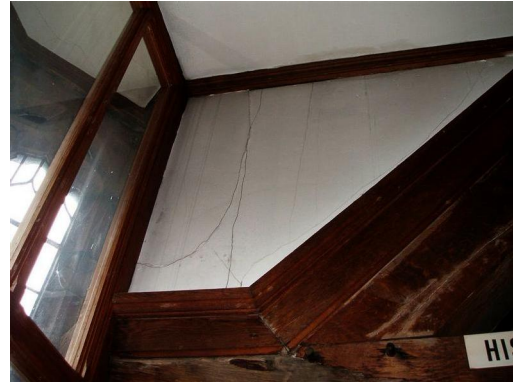
Water stains by and in dormers of west and east windows to north and south sections, appear to be dry. **Monitor.**

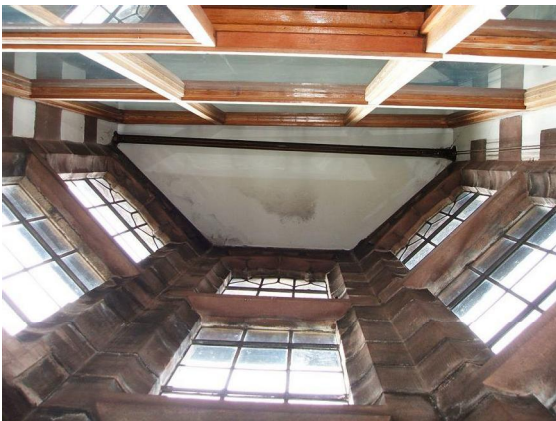
Stains spallig on south oriel ceilings.

Monitor, clean & redecorate.

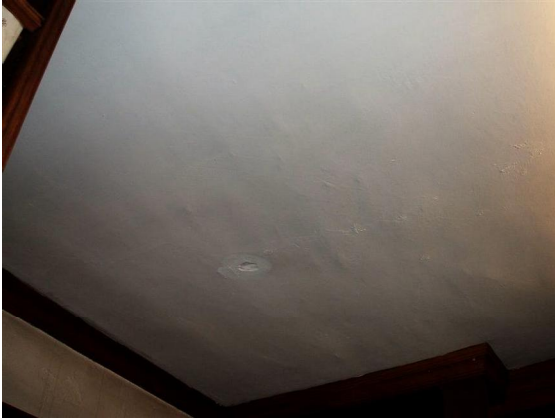
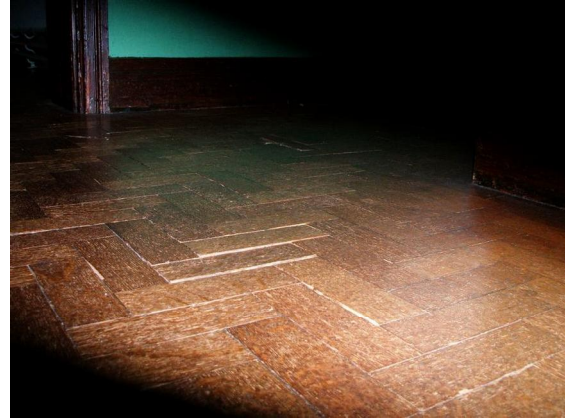
Ceilings: Below the galleries, much patching to previous services locations; very uneven to west bays 2 & 3 from south. Local cracking adjacent south stair south door and to south east & south west corners.

Local repair.

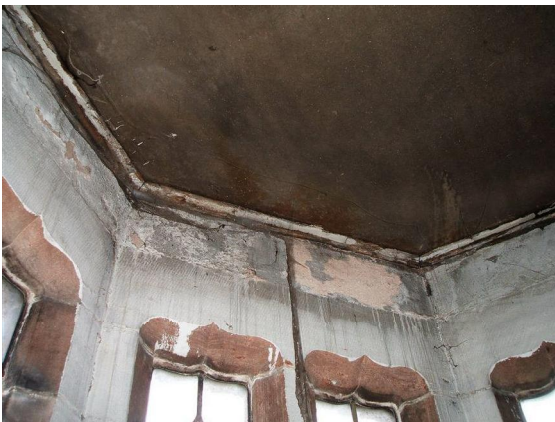
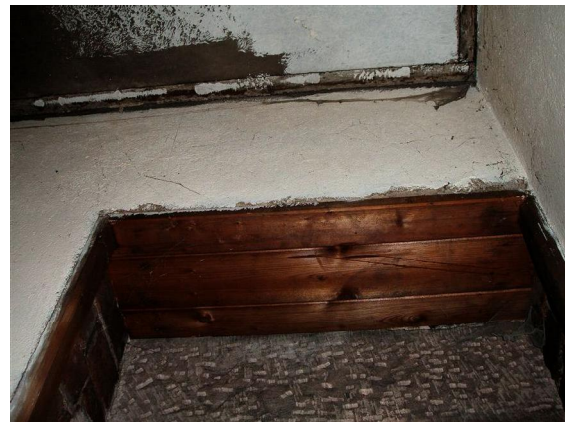
Turret Stair: Water stains at high level north west. Damaged plaster to west.

Local repair & redecorate.

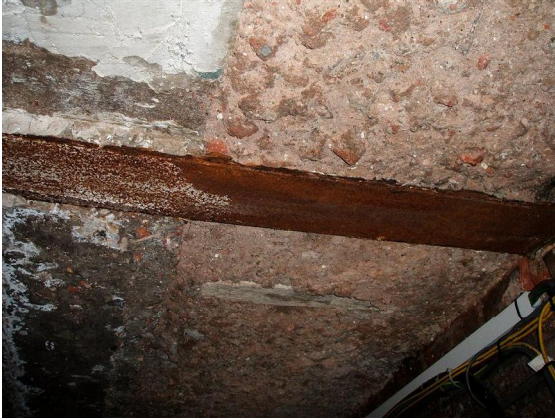
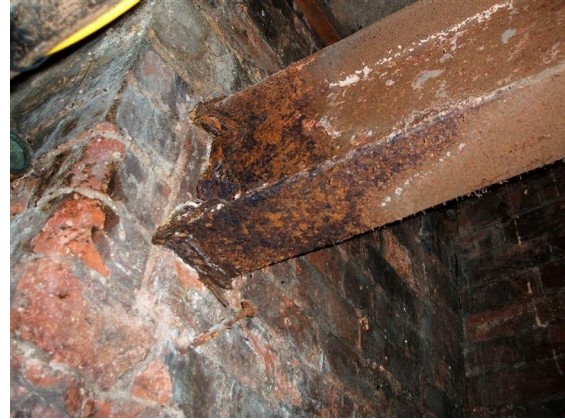
Ceilings: Concrete; exposed steel joists. General corrosion in south light well and adjacent; undersides exposed and generally corroded.

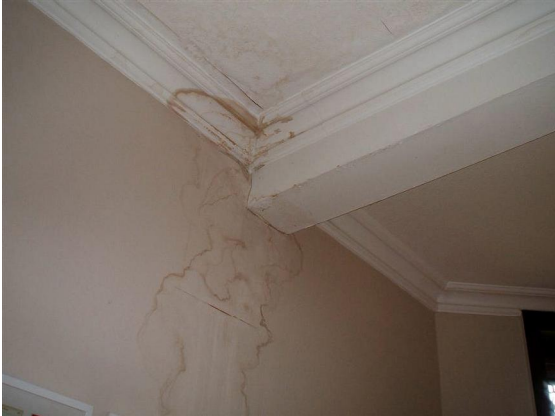
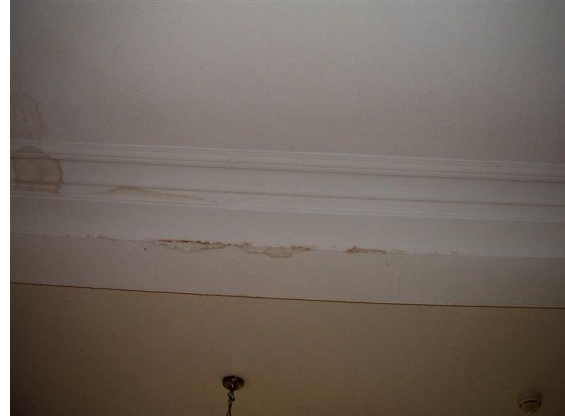
Water stains to west by beam end.

Repair.

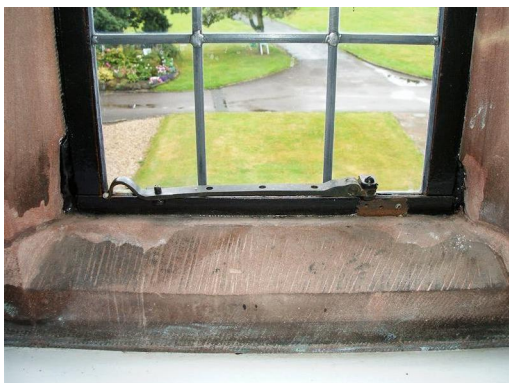
Spalled stonework to south east window opener. Most of the mullion feet are eroded. Repaired loose plaster to staircase window west jamb.

Local stonework, repair and patching to plaster.

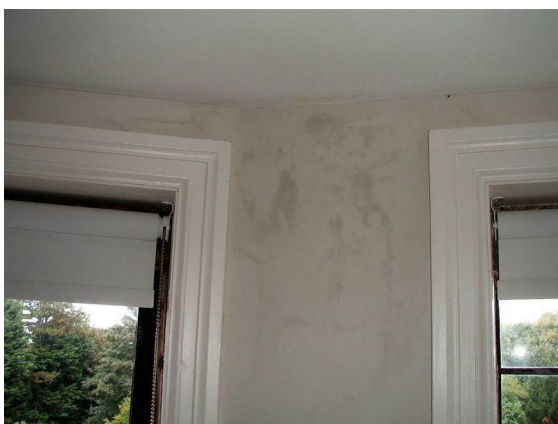
Damp stains room 24 north of below gable.

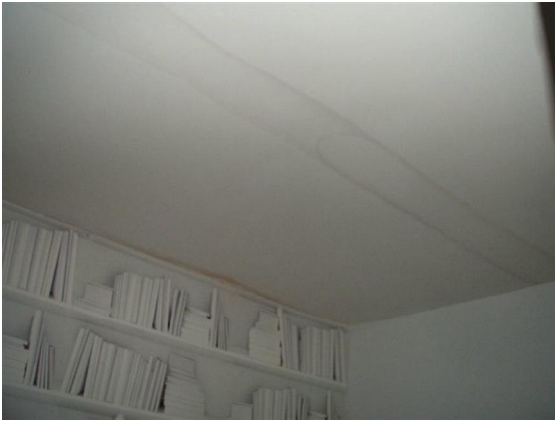
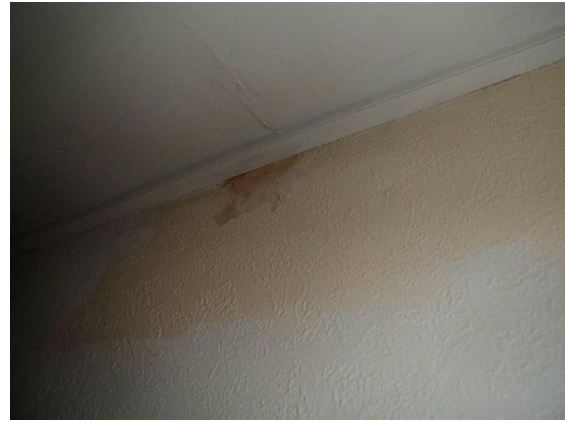
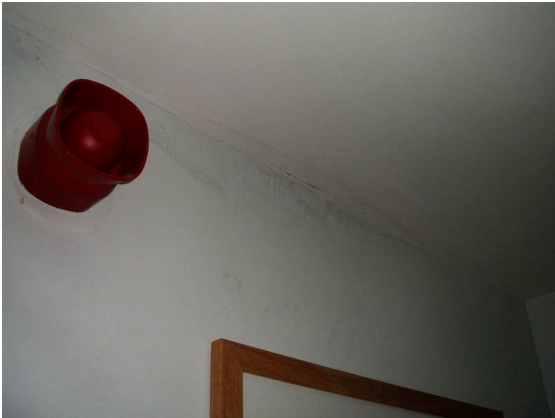
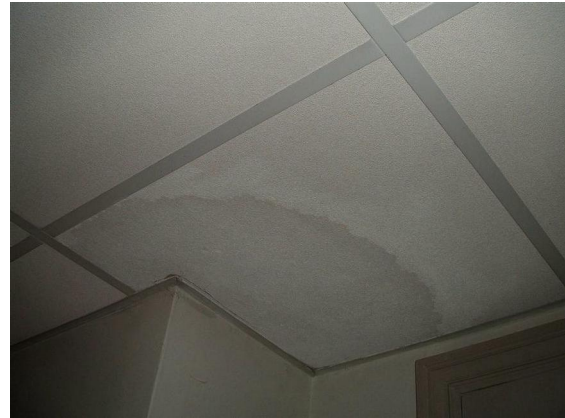
Water stains in 31 & 32 and adjacent corridor (see concrete flat roof defects).

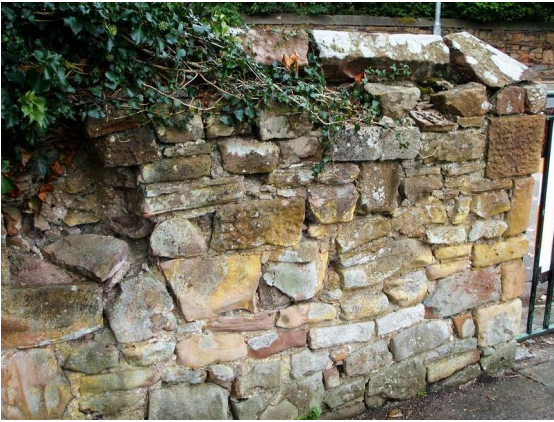
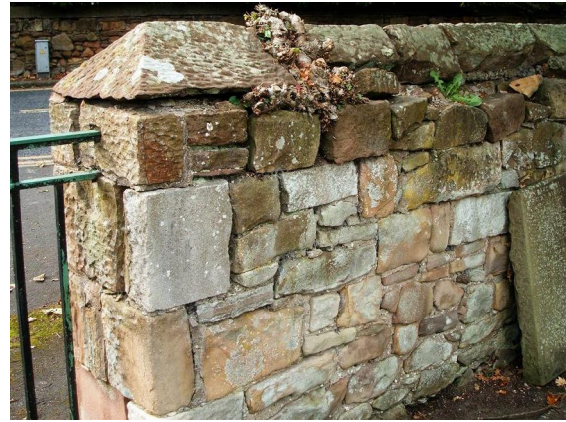
Loose stonework adjacent to the main central gate. -Pump recess sound, missing copings loose and falling away adjacent to west and by west gate.

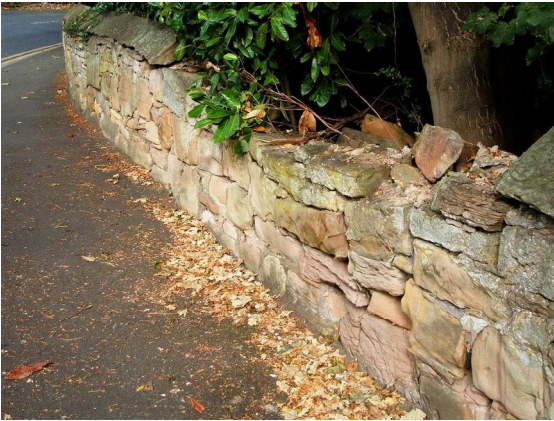
South West Section: Onto Gladstone way, partly collapsed inward, loose mortar and to upper levels of stonework, severe erosion; -wall terminates to west. **Rebuilt and repoint.**

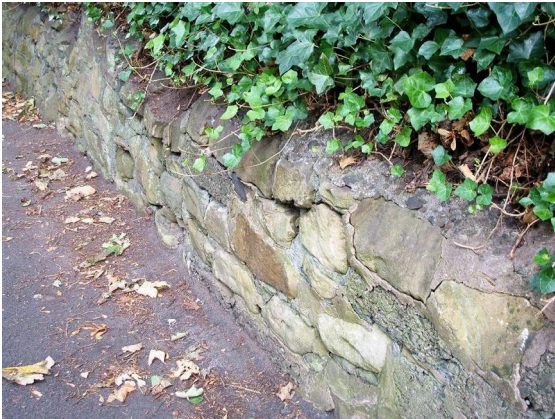
West Wall: Retaining higher ground mostly obscured by ivy; a number of areas settled, repair to centre west much loose mortar ó hard, the stonework eroded. Loose stones low level north west (opposite south end of Masonic hall).

Check below ivy. Generally repoint. Ensure drainage holes at base. Reset all loose areas.

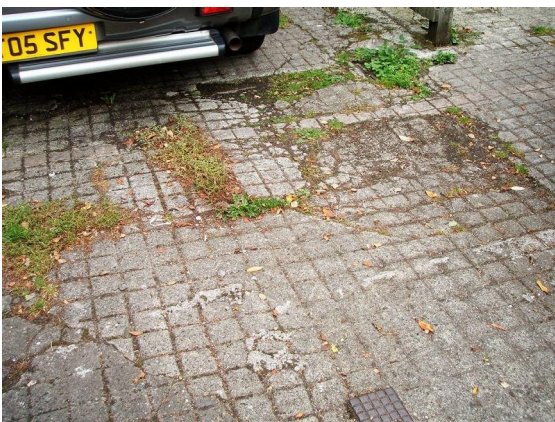
Kitchenyard, the tarmacadam approach has settled and is ponding; concrete area settled and cracked, poor. Loose brick to drain surround ó extensive patching.

Re-surface

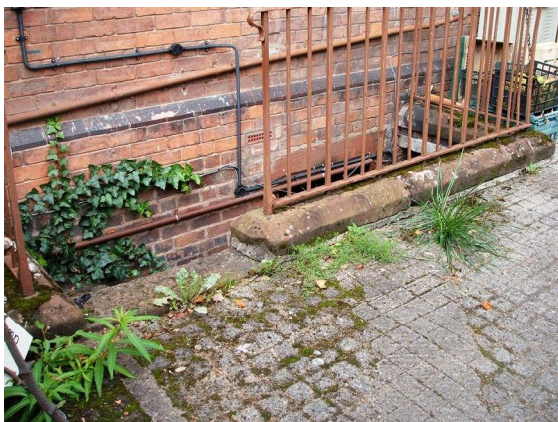
Vegetation adjacent to boiler access.

Ramps and paths adjacent to the north chapel corridor in good order. But the new path has not been finished up to this hazard. Vehicle damage to south, stones broken.
