ROOFS east wing continued

ROOFS continued

DRAINAGE

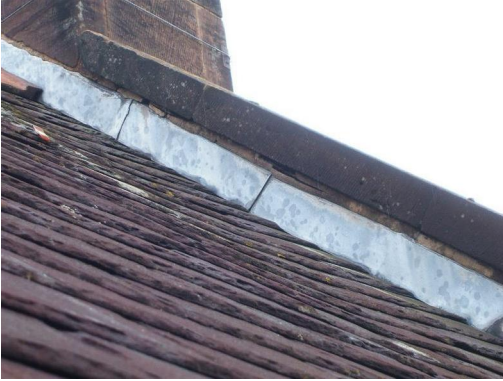
Flashings to east gable split, becoming loose high level.

Refix flashings and patch.

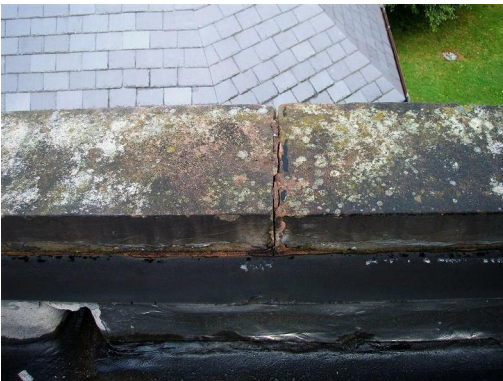
Dormer Roof: Above last, lead and mineral felt, bitumen to east, poor. Leaking. **Renew.**

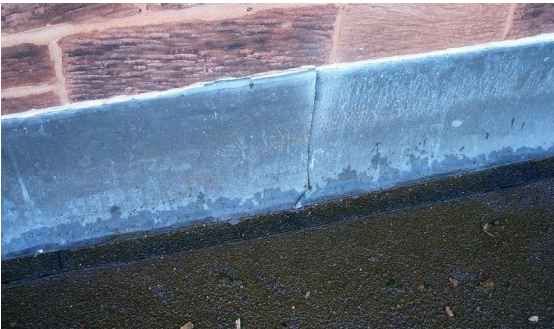
Conference Room: Single storey extension to last, mineral felted, sound, pointing missing to section of flashing to east & south. Debris in east gutter. **Locally repoint, clear gutters.**

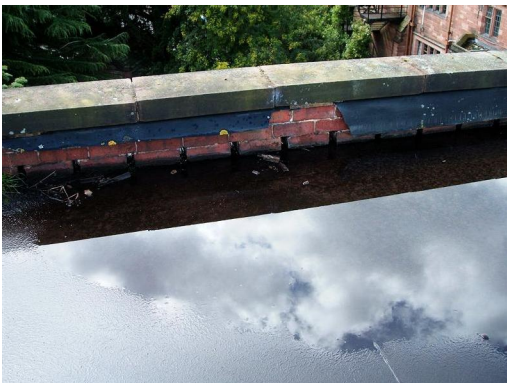
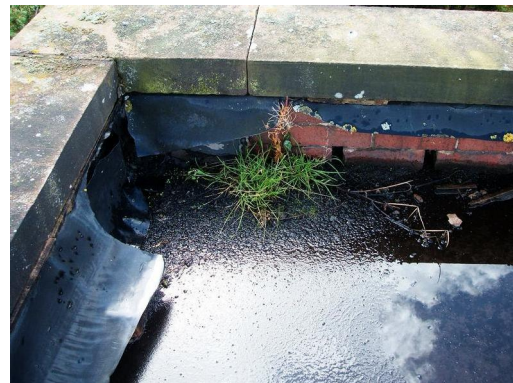
Cracking north/south to north east and north west, general failure to parapets, loose, felt covers, pointing missing; coping joints all poor.

Monitor path. Renew in due course.

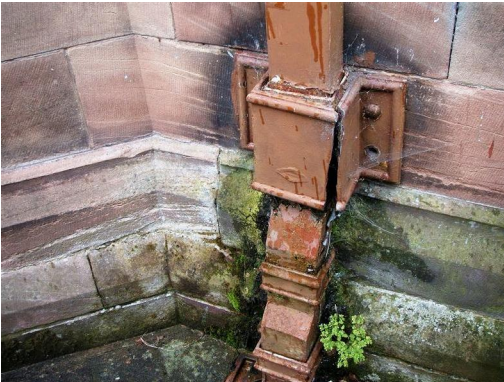
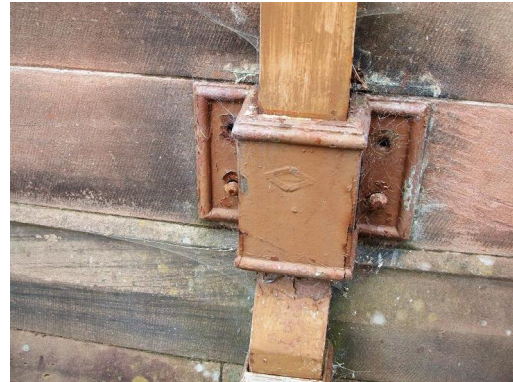
No.8: Library north west, c.i.; collar centre fixings missing, corroded rear, tight to wall, leaking. **Refix/part renew?**

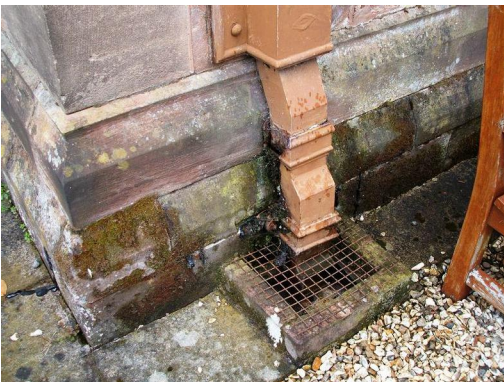
No.10: Library south west, bottom collar broken

Ditto.

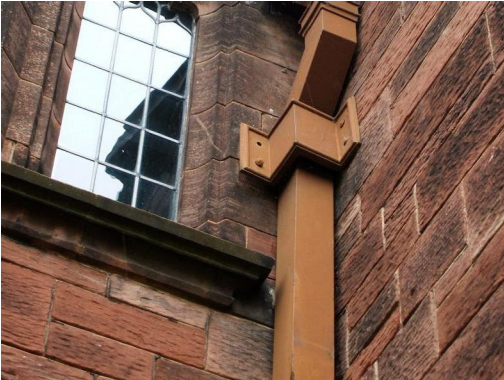
No.15: Centre block to west of porch, lower section splitting, top collar loose.

Renew part, refix.

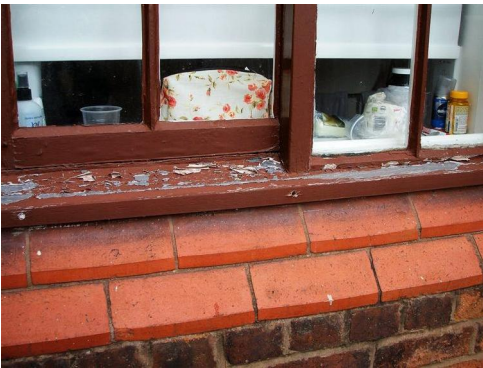
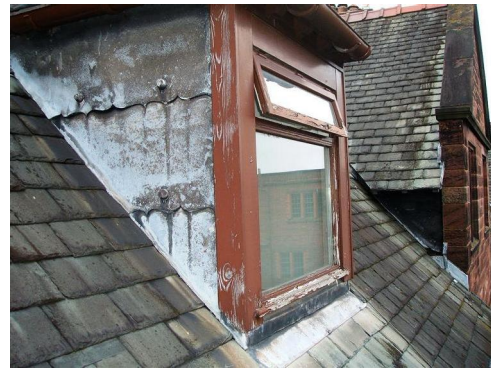
Timber frames, paintwork poor.

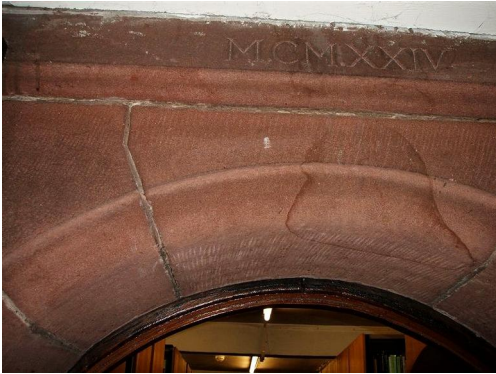
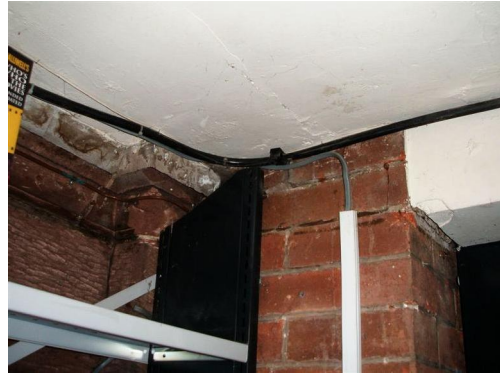
Slight cracking in window reveals and over south door and adjacent.

Check and repair.

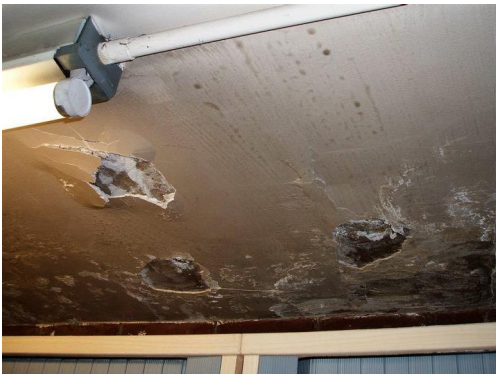
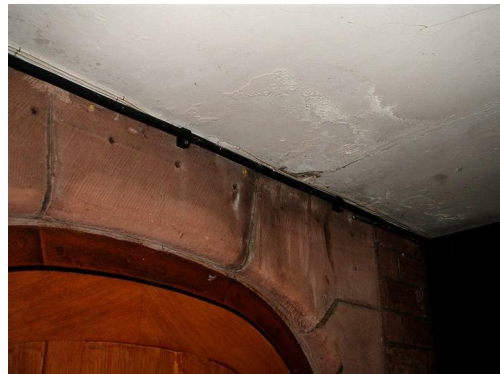
Generally: All as last, severe distress on ceiling, lintol to door to library spalling.

Replaster, follow roof repair.

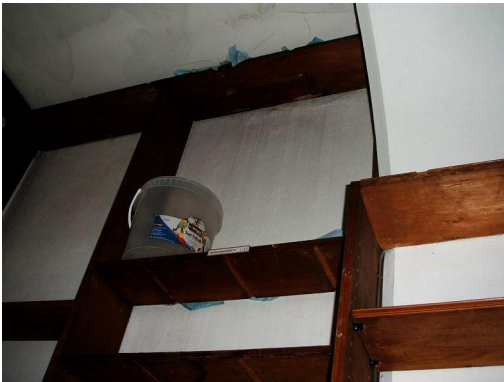
Suspect wet on west staircase west wall. Water ingress on west porch staircase, a bucket dry at time of inspection, added plaster and at first floor level. **Repair above & monitor.**

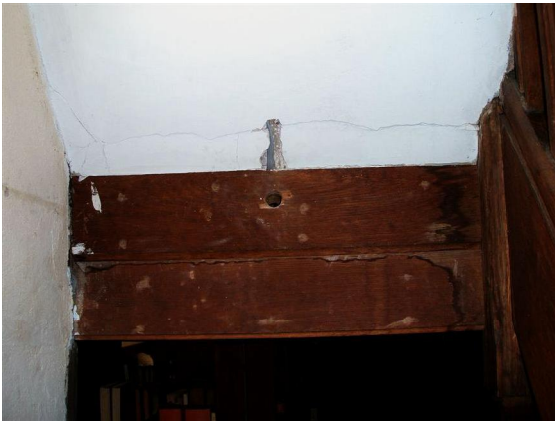
Floor: Wood block, sound. Damage to south west by leaking radiator connection and locally by west door.

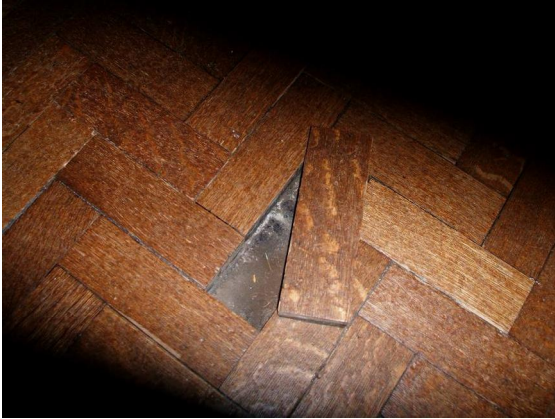
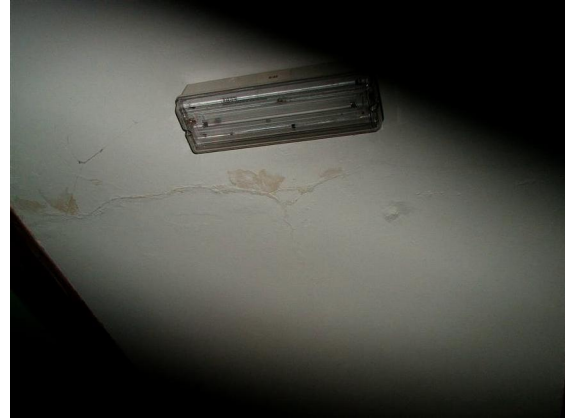
Floor: Wood block to south, one loose. Stonework stained to south west door.

Reset and level.

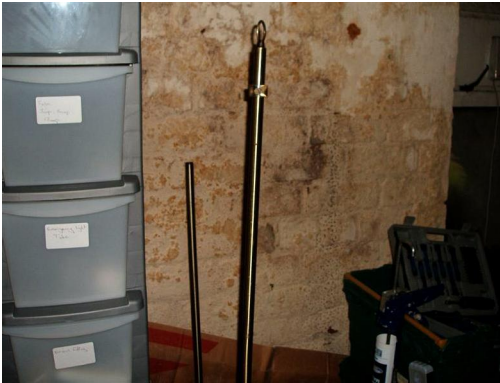
Walls: Painted brickwork, damp & spalling to west.

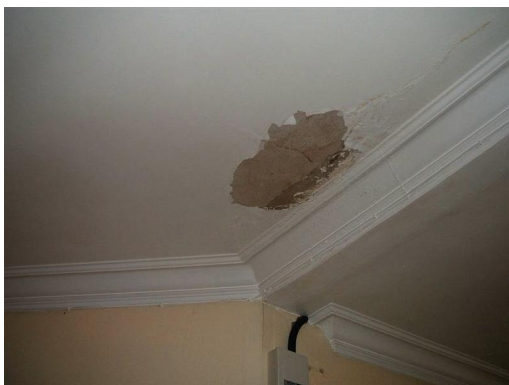
Ceiling: Plastered cracked and settled by west stairs, panelled (as below) over staircase and sound.

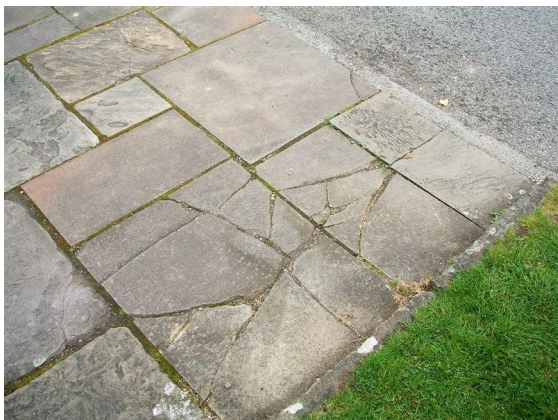
Ramps and paths adjacent to the north chapel corridor in good order. But the new path has not been finished up to this hazard. Vehicle damage to south, stones broken.
